## 6. MRF Assessment

### 6.1 Introduction

### 6.2 Review of MRF Site, Building and Operations

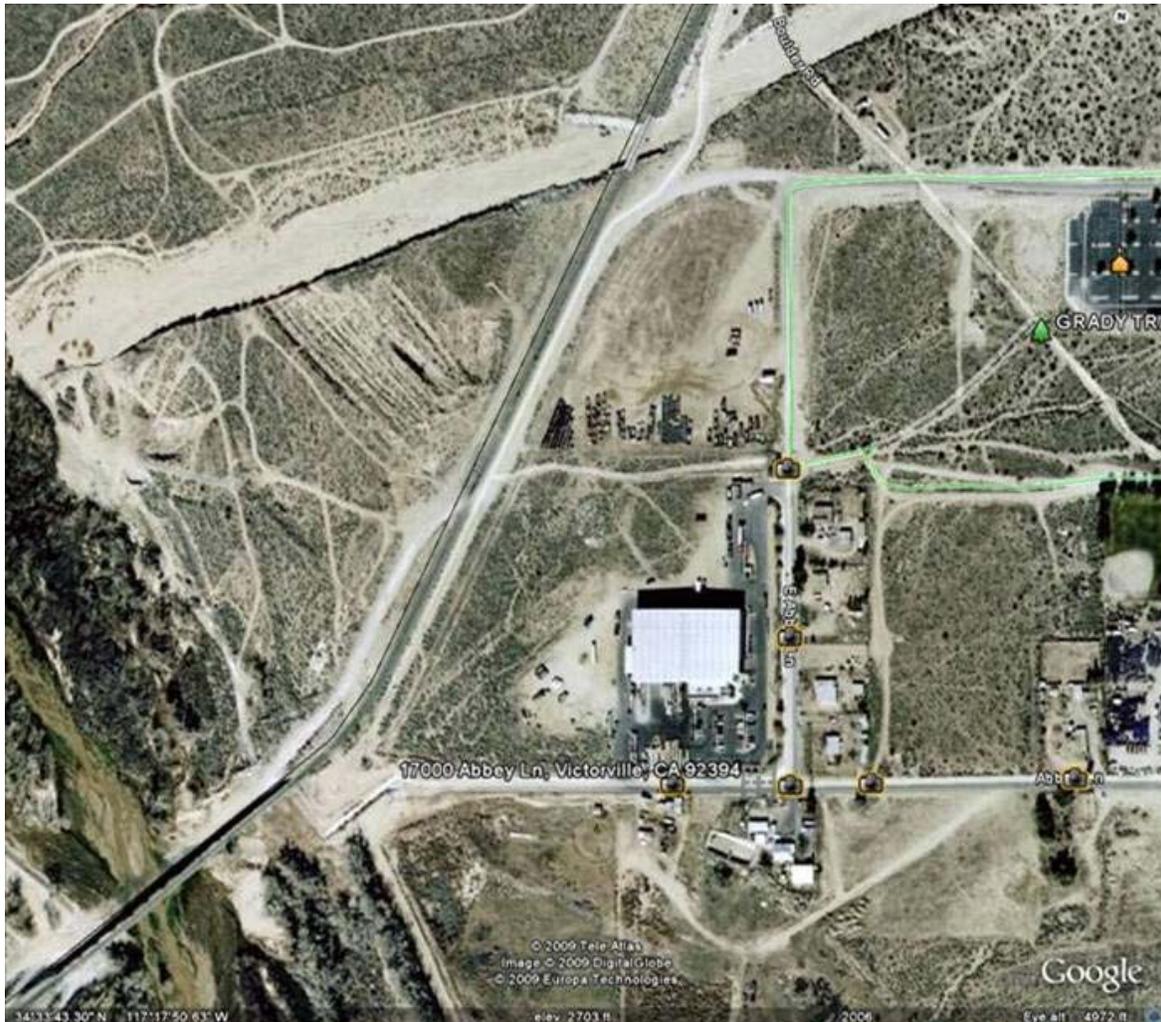
Figure 6-1 – Aerial Photo

The MRF facility is located in the southeast portion of an approximately 12-acre site located on the corner of Abbey Lane and Biminy Lane in Victorville, CA. An aerial photo of the area that includes the MRF is presented in Figure 6-1. The southeastern portion of the site is paved. Travel lanes from the entrance gate located in the northeast corner of the site extending south to the truck scale and to the MRF building are also paved. The entire western half of the site as well as a large majority of the northern half of the site is unpaved and undeveloped.

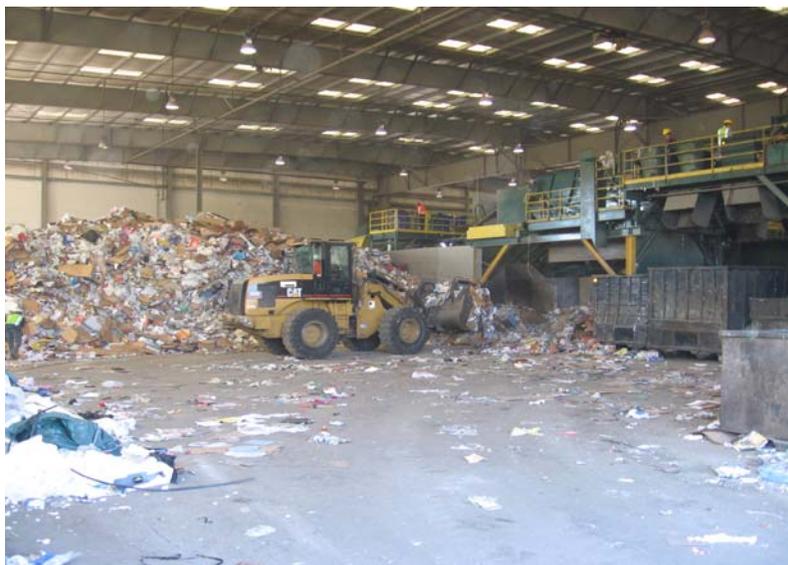
Photo 6-1: Tipping Floor and Residential Infeed

The processing system is primarily located in the central part of the building. The processing system occupies over 85 percent of the processing building area, providing virtually no

room for system or equipment expansion inside the building without increasing the size of the building in the north direction.

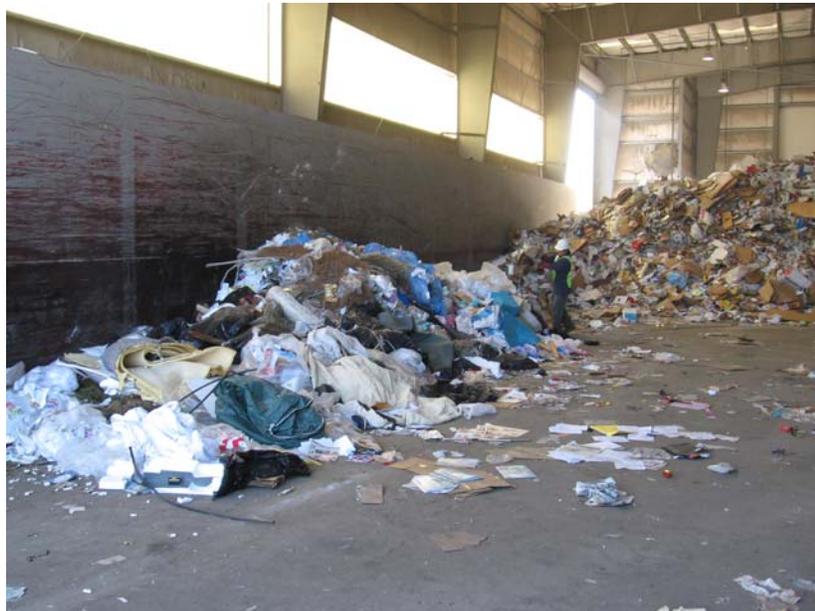
*Photo 6-2: Manual Floor Sorting of Select Load on Tipping Floor*

On the tipping floor, Burrtec personnel (two sorters) perform floor sorting of “select loads” which consist of dry commercial and industrial solid waste loads diverted to the MRF. These loads are rich in plastics, metals, OCC and wood as shown in the photo. The sorters manually remove these materials from the pile and transfer the recoverable materials to roll-off containers and self-dumping hoppers located just outside of the north wall of the building. The wheeled bucket loader assists in the transfer of these materials as well as transferring the remaining non-recoverable material.

The only observed area of concern on the tipping floor during the assessment was the actual location of the stockpile of material on the tipping floor. The material is stored very close to the southeast tipping door when much of the rest of the floor is empty. This results in material migrating from the floor and blowing out onto the site. Burrtec could perhaps better position the pile away from the southeast

door in order to reduce the amount of material blowing onto the site and elsewhere, especially when there is sufficient, less utilized space in the central part of the tipping floor. Burrtec could also consider keeping this door partially closed when not in use.

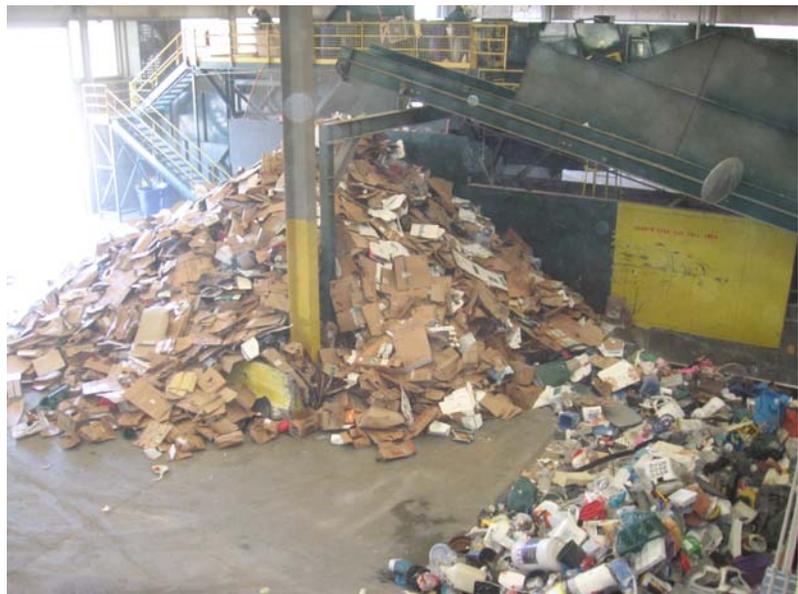
Photo 6-3: OCC Pile – Consider Installation of Bunker Wall Running North-South at Building Column

Overs from the pre-sort platform transfer to the OCC Screen. The OCC Screen is constructed of steel stars which separate OCC from the remaining material. The screen does a very good job of separating OCC, which is transferred approximately 180 degrees via conveyors to a stockpile on the process floor prior to baling. The OCC quality was observed to be excellent. The facility should consider installing a bunker wall in a north-south direction to

separate the OCC pile from the other materials that are unloaded on the floor for direct baling. For example, at 2:00 p.m. on Tuesday (September 30, 2008), the OCC pile was observed as being contaminated by a large pile of rigid plastics that were unloaded for baling.

- A bunker wall which would run in a north-south direction to separate the OCC pile from the other materials that are unloaded on the floor for direct baling should be considered. For example, at 2:00 p.m. on Tuesday, 9/30, the OCC pile was observed as being contaminated by a large pile of rigid plastics that were unloaded for baling.

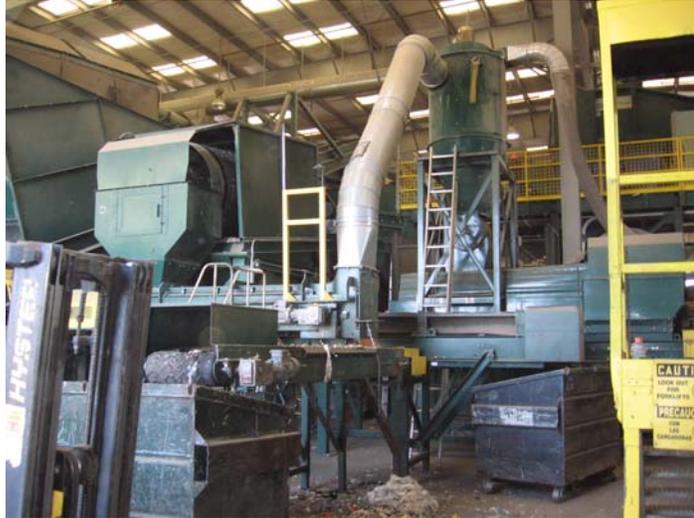
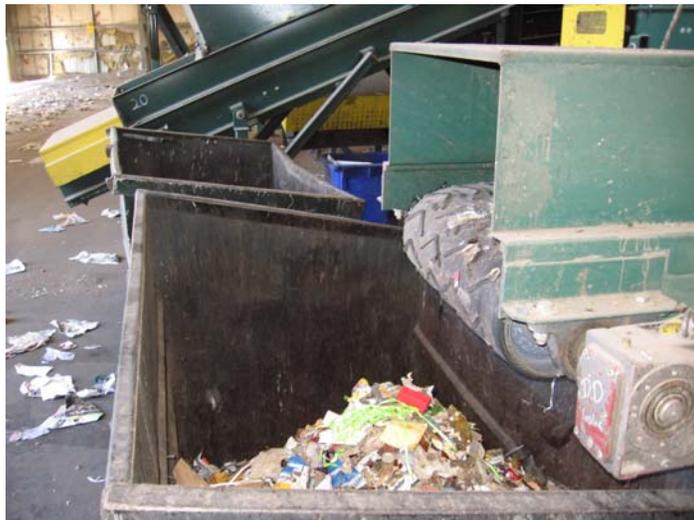
*Photos 6-4 and 6-5: Mixed Broken Glass System – Undersized Hopper Storage System*

Overs from the trommel, consisting of broken glass, small containers, small paper and small trash transfer via conveyor to a two-cubic-yard hopper. A vacuum system mounted above the transfer conveyor removes “lights” from this material stream. The lights, which consist primarily of shredded paper and dust, are dropped onto the residue transfer conveyor. The vacuum system does an effective job in removing light materials as verified through observing the separated streams. Burrtec should clean the filter bag more frequently as it may further improve performance. As the mixed glass hopper fills, it is transferred by forklift to a roll-off box outside. This material is then transferred to Strategic Materials, Inc. (SMI), for further processing, i.e., separation of glass from the other materials. SMI runs monthly audits of this material for the purposes of establishing payments to Burrtec. Recent studies indicate this material is 64 percent glass, and 36 percent trash and small containers.

The mixed glass processing system is the primary system in the MRF that is not sufficiently designed for proper material handling, even at the current tonnage levels. The two-cubic-yard hoppers, shown in Photos 6-4 and 6-5, used for fines and mixed broken glass are undersized and present significant material handling problems. Due to inadequate storage capacity, the hoppers must be removed and dumped numerous times per day during regular operations. This results in excessive material handling and spillage around the hoppers that must be frequently cleaned. The proper design, which the facility should still consider, especially if mixed waste material is

introduced to the system, would be to convey these materials to storage bunkers located outside the south wall of the building, perhaps adjacent to the ramp where paper and plastic bales are currently stored. There appears to be sufficient room in the bale storage area (Photo 6-6). This material should be handled in bulk, which is the industry standard, as opposed to the “two-cubic-yard at a time” handling method.

- The mixed glass processing system is the primary system in the MRF that is not sufficiently designed for proper material handling, even at the current tonnage levels. The two-cubic-yard hoppers used for fines and mixed broken glass are undersized and present significant material handling problems. Due to inadequate storage capacity, the hoppers must be removed and dumped numerous times per day during regular operations. This results in excessive material handling and spillage around the hoppers that must be frequently cleaned. The proper design, which the facility should still consider, especially if mixed waste material is introduced to the system, would be to convey these materials to storage bunkers located outside the south wall of the building, perhaps adjacent to the ramp where paper and plastic bales are currently stored. There appears to be sufficient room in the bale storage area. This material should be handled in bulk, which is the industry standard, as opposed to the “two-cubic-yard at a time” handling method.

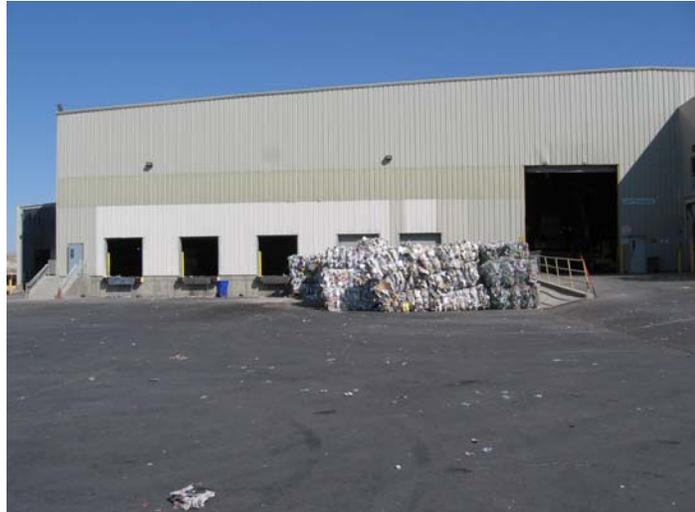
Photo 6-6: Bale Storage Area – Location to Consider for Glass Storage Bunkers

The facility should also consider installing rotating brushes on the top sides of the trommel in order to clean the screen which appears to plug with material. This would especially be necessary if mixed waste processing were introduced to the system. Dust in the mixed glass system did not appear to be a problem, perhaps due to the vacuum system as well as the proximity to the overhead door on the south wall.

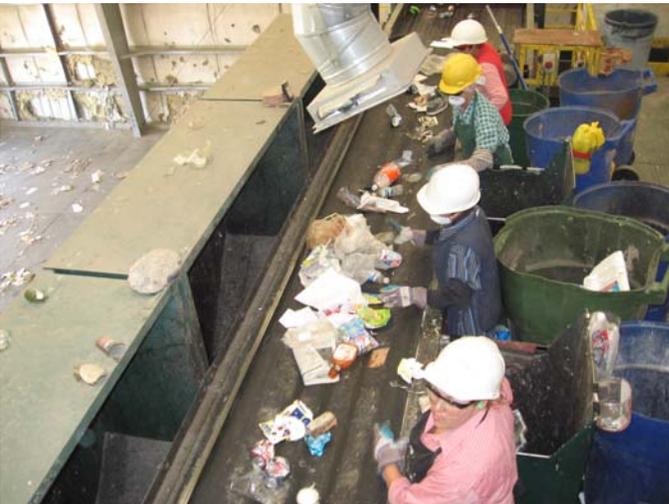
*Photo 6-7: Glass Sorters and Paper Observed on the Glass Sort Line*

After the magnet, the stream drops onto the glass sorting conveyor where four sorters are stationed for colored glass sorting. Green glass, clear glass and brown glass are sorted respectively by the first three glass sorters into toss across chutes. The glass

There is a considerable amount of paper on the glass sort line which is not able to be completely removed by the four glass sorters. This paper ends up being transferred to the residue system. In order to reduce the paper going to residue, it is strongly recommended that the facility dedicate one person to removing only paper from the container sorting line.

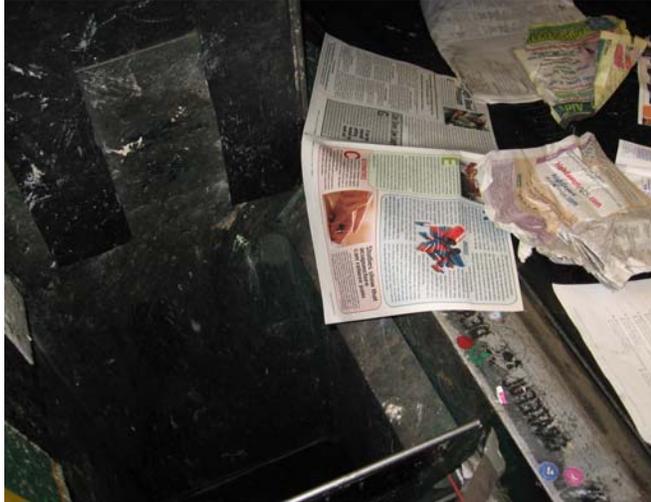
*Photo 6-8: Paper Dropping Into Container Sorting Chute*

The biggest issue we saw on the MP sorting line is that sorters are actually contaminating the container line with paper. The large majority of the paper that ends up on the container line is coming from the MP sorting line. As they sort containers, sorters assigned to remove containers from the MP sorting line accidentally drag pieces of MP into the sorting chutes, and these pieces of mixed paper get recirculated back to the container line.

These sorters should be sorting containers by grabbing and dropping the containers into the chutes, rather than grabbing and sliding or dragging the containers into the chute, thereby catching paper along the way. It is highly recommended that Burrtec evaluate these activities and retrain the sorters to properly sort the containers. The residue rate will drop as will the amount of paper being lost to residue.

Specifically, the loss of paper within the current MRF system should be closely evaluated, including consideration of the observations and recommendations of this report, in order to reduce the amount of paper currently being lost to residue. A primary recommendation is that one person be dedicated to removing only paper from the container sorting line. Further, the activities of the paper sorters need to be evaluated and retraining provided in order to reduce the paper being accidentally dragged into the containers sorting chutes.

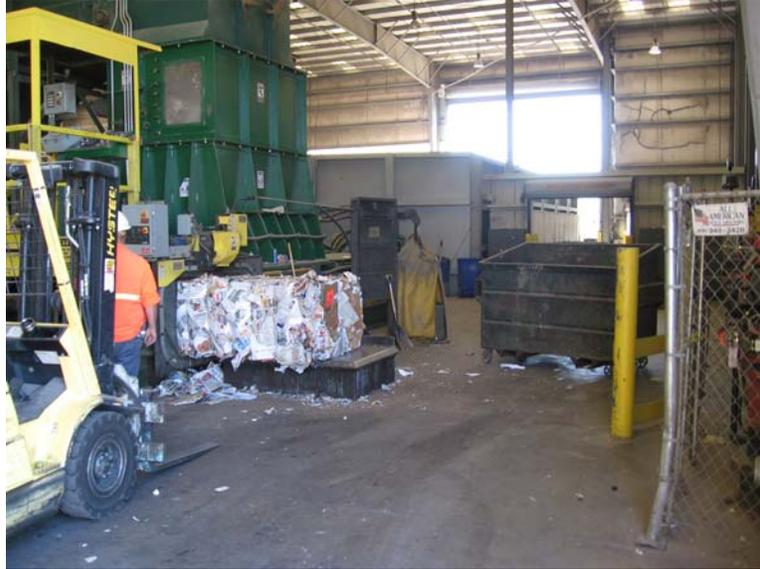
*Photo 6-9: Constrained Baler Eject Area and Traffic Lane*

The location and orientation of the baler in the MRF building is a design flaw and presents a significant bale handling and traffic problem to operations. The baler is located approximately 15 feet from the south wall of the building. With a safety bollard added to protect the wall, there is only about ten feet of space for bales to eject from the baler. This ten feet is also a forklift access route from one side of the process area to the other. This requires the baler/ forklift operator to have to move each bale to storage as it is created, as opposed to allowing several bales to be created and then moving multiple bales at a time, a standard design feature in the industry. Without a major redesign of the system and relocation of the baler, it would be difficult to correct this issue.

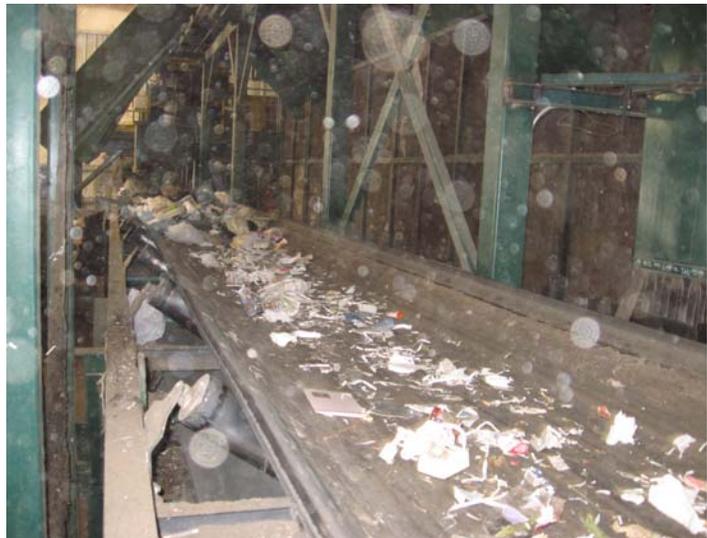
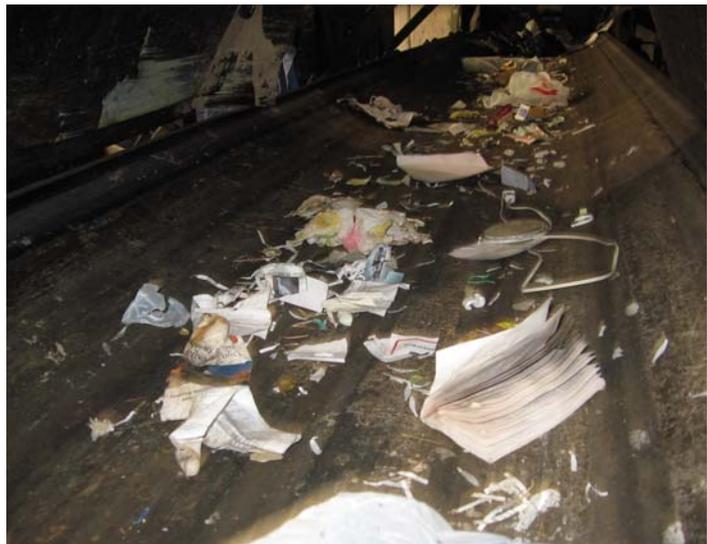
*Photos 6-9 and 6-10: Paper on Residue Line*

The majority of the paper that ends up in residue comes from points 4 and 5 noted above. The residue is then conveyed through the west wall to a trailer which transfers the residue to the landfill.

The GBB Team recommends that the facility immediately implement a program to evaluate and reduce the residue rate. This program would include:

- Assigning one person with ultimate responsibility for evaluating and developing action items necessary to reduce residue.
- Evaluate and implement recommendations in this Report that deal with residue reduction.
- Evaluate costs and benefits of the current Select Load processing methods.
- Develop recommendations for improving curb enforcement in order to reduce the contamination of residential loads when picked up at the curb.
